EFI USA / METHANE INSPECTION, REPAIR &amp; SITE INTEGRITY PROGRAM

| FACILITY | INSPECTION DATE | SYSTEM | AREA SCANNED | METHODS |
| Sample Digester Site | 00 / 00 / 2026 | Covered anaerobic lagoon | 6.4 acres cover | Aerial + ground, gas sample, repair |

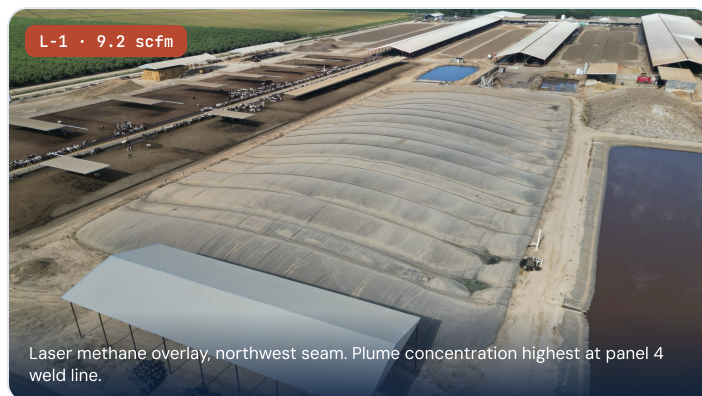
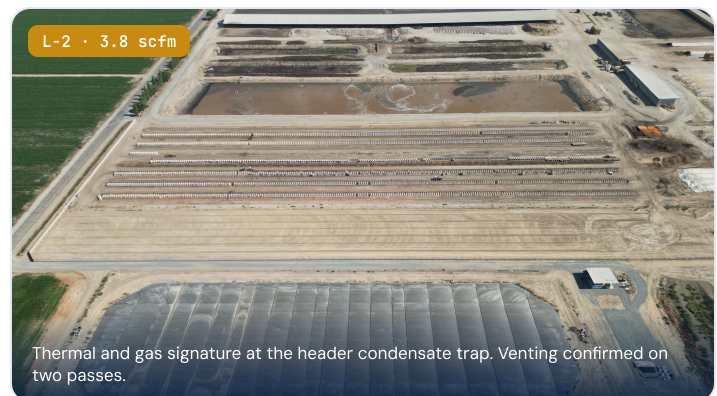
The laser sensor detects and quantifies methane in the air above the cover as the drone flies a grid, and a ground walk-down with a portable analyzer confirms each source and catches leaks the aerial pass cannot see. Each release below is a real location you can walk to, with an estimated leak rate and the action taken. The largest is a lifted cover seam, the kind of thing that is invisible from the ground but obvious from the air.

| ID | LOCATION | SOURCE | EST. RATE | SEVERITY | ACTION |
|---|---|---|---|---|---|
| L-1 | NW cover seam, panel 4 | Lifted / unwelded seam | 9.2 scfm | High | Seam re-weld scheduled. Above reportable threshold; repair documented. |
| L-2 | Header condensate trap | Trap venting to atmosphere | 3.8 scfm | Medium | Closed on site. Trap re-seated and routed to collection. |
| L-3 | SE ballast tube boot | Penetration boot degraded | 2.1 scfm | Medium | Closed on site. Penetration re-booted and clamped. |
| L-4 | Flare pilot | Incomplete combustion at low flow | Trace | Monitor | Tune flare pilot. Confirm destruction efficiency. |

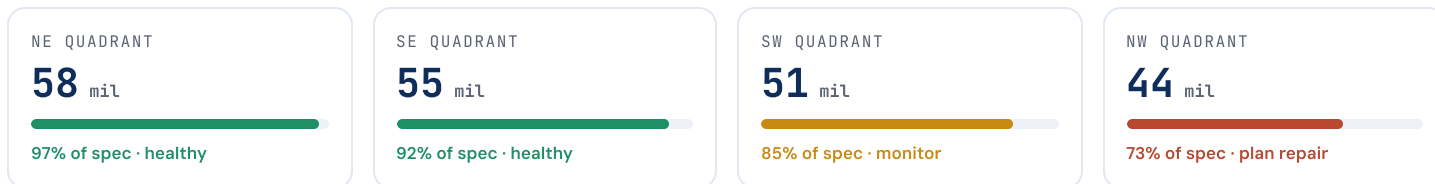
The thermal pass flags stressed and ponding areas from the air. On the ground, EFI takes ultrasonic thickness readings on the HDPE cover at set stations and compares them to the original specification. That tells you not just that the cover is aging, but where, by how much, and roughly when it will need attention.

Spec at install was 60 mil. The northwest quadrant, the same area as the L-1 seam leak, has thinned to 44 mil, a 27 percent loss. That is not a failure today, but it is the first place to fail, and it is where you should budget a planned repair rather than wait for an unplanned one.

| <b>18 to 24 mo</b> | <b>Planned NW quadrant repair.</b> Budget a cover patch or panel replacement before the thinned zone drives an emergency shutdown. EFI can hold a re-inspection to track the trend. |
